ROCKY MOUNTAIN NATIONAL PARK

TRAIL RIDGE ROAD

CO PRP 10 (3)

GEOTECHNICAL REPORT Report # CO-PX-ROMO-01-01

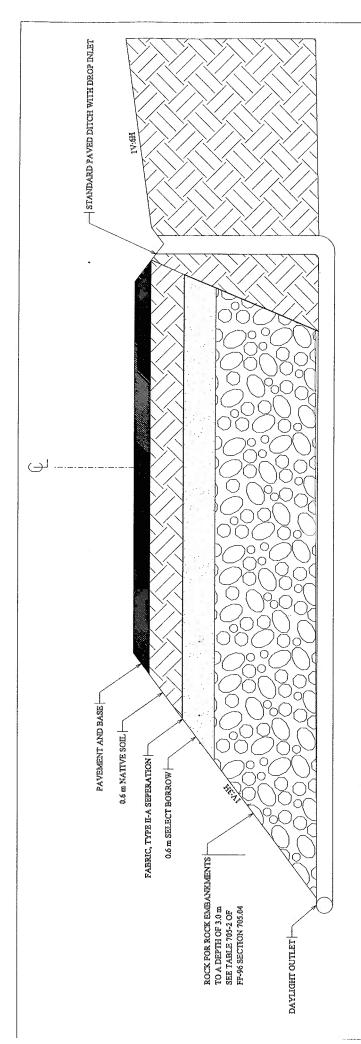
FIGURE 1: SUB-EXCAVATION SCHEMATIC FOR SITE A

Site A: A large section, about 500 ft (150 m), of the road has subsided up to two feet (0.6 m) below the original grade. Although both lanes have settled, most of the subsidence has occurred in the outbound (west) lane. Several transverse cracks were mapped at about 20 ft (6 m) intervals. Shoulder wash out and drop off were also apparent within this area. Two non-functional cross drainage pipes existed within the subsided area. The drainage pipes are 8 and 24 in (200 and 600 mm) in diameter. Both pipes contained trapped sediments and the inlet to the 8 in (200 mm) pipe could not be found. At the south edge of this zone, a 5 ft (1.5 m) wide paved drainage ditch with 6 in (150 mm) curve existed with a drop inlet to the 24 in (600 mm) cross pipe. At the north edge of the subsided zone, another drainage ditch with gravel was installed. No ditches existed along the subsided zone. The natural slopes on the east and west side of this site are about 1V:6H, while the fill slope on the west side (outbound) of the road is 1V:3H. These gentle slopes combined with the location of the site in a drainage valley, cause most of the snow runoff to either penetrate the granular soil or run over the road surface, washing the silt fines particles out of the subgrade, causing subsidence.

For embankment stabilization, it is recommended that, 500 ft (150 m) long section between the end of the paved drainage on the south end and the end of the cut slope on the north end is sub-excavated, rebuilt, and drainage improved. The subexcavation should extend across the entire road prism. Materials excavated should be to a minimum depth of 10 ft (3 m). Figure 1 of Appendix D shows a schematic of the subexcavation and subsurface rebuilding plan. Drainage should be improved by installing paved ditches with a drop inlet and standard 24 in (600 mm) culvert. The excavated area should slope 2% towards the center point of the zone and 2% towards the edge of the outbound (west) lane, allowing the water to flow into an outlet ditch.

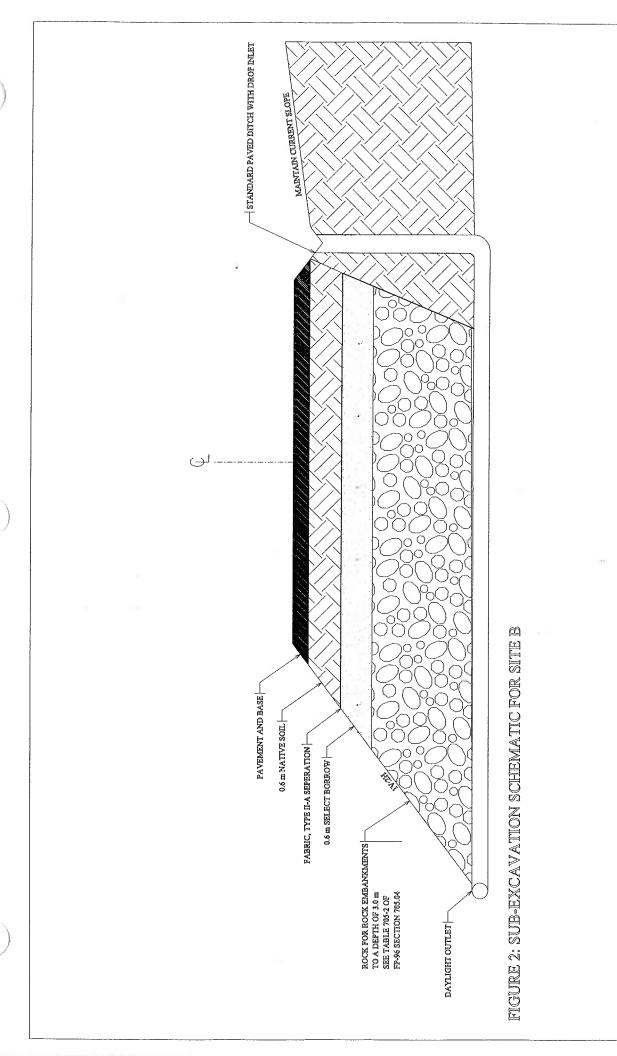
Site B: A 300 ft (90 m) section of the outbound lane has subsided. This portion of Trail Ridge road consists of cut and fill sections constructed on an exposed talus slope. The height of fill on the west side of the road is approximately 15 ft (4.5 m) has slopes slightly steeper than 1V:2H. The talus slope on the east side of the road has slopes up to 1V:1H. A paved ditch with a 6 in (150 mm) curb and 24 in (600 mm) drop inlet provides drainage for the north end of this site. The intersection of the paved ditch and the talus slope on the east side of the road provide drainage for the majority of this section. Transverse cracking of a low to moderate nature was found throughout this road section.

The problems within this section of Trail Ridge Road seem to be related to a loose fill material. It is recommended that a zone, starting at 50 ft (15 m) south of the "DIP" sign on the north side and extending to the south approximately 300 ft (91 m), be sub-

excavated and rebuilt. The sub-excavation should extend across the entire cross section of the road and to a minimum depth of 10 ft (3 m). The clay discovered in boring 00P-102 should be removed and backfilled with clean, suitable granular material. It is also recommended that the shoulder fill slope be flattened to 1V:2H on the west side of this section. The condition of the drop inlet and culvert on the north end of this section should be determined and replaced if necessary. Figure 2 of Appendix D shows the recommended sub-excavation and subsurface rebuilding plan.

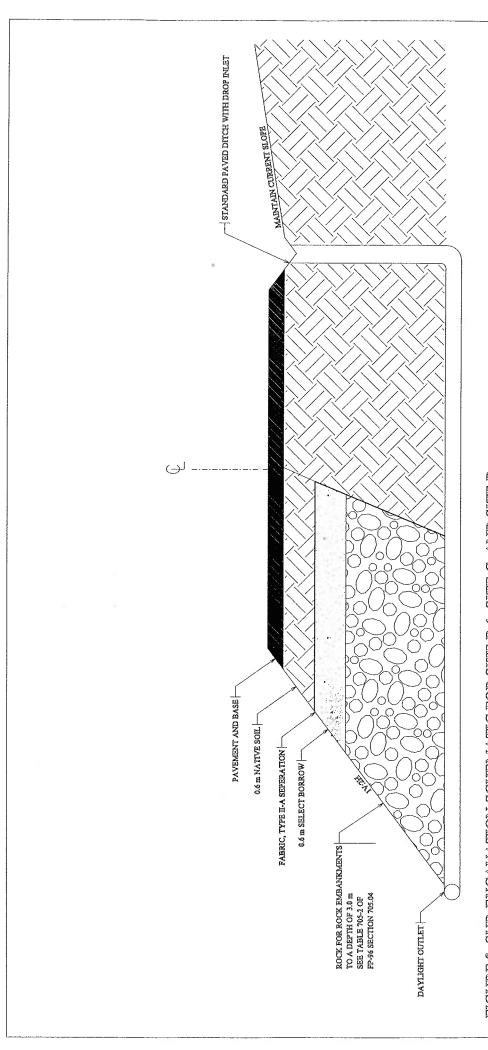
FIGURE 3: SUB-EXCAVATION SCHEMATIC FOR SITE B-1, SITE C, AND SITE D

Site B-1: An additional 300 ft (90 m) directly to the south of site B was found to have several dips in the outbound (west) lane. Boring 00P-101 was located within this section in the inbound lane. A silty sand with rock fragments was encountered to a depth of 8.2 ft (2.5 m). From 8.2 ft (2.5 m) to 12.5 ft (3.8 m) the material consisted of decomposed granite. Two standard penetration tests were conducted within this boring and both resulted in refusal. While the inbound lane consists of dense material, the outbound fill material visually appears to be loose, causing the subsidence problems.

The subsidence problems within this section appear to be related to both snowmelt infiltration and a loose fill material. Drainage along the road seems to be adequate and in working order. It is recommended that the outbound (west) lane be sub-excavated and rebuilt throughout the section. This sub-excavation should extend from the road centerline to the outbound shoulder and to a depth of suitable material. Figure 3 of Appendix D shows the recommended sub-excavation and subsurface rebuilding plan.

The cause of subsidence at this site seems to be closes related to those found at site A. It is recommended that this 30 m (100 ft) zone be sub-excavated and reconstructed. As the problems seem to be occurring in the outbound lane only, the sub-excavation should be limited to the area between the road centerline and the outbound shoulder. It is

While site B takes precedence over site B-1, it is recommended that the outbound lane be sub-excavated and rebuilt, if funds warrant. Figure 3 of Appendix D details the recommended sub-excavation and subsurface rebuilding plan.

thought that the subsurface material found at Site D will be similar to the material found at the other sites. Therefore, sub-excavation should proceed to a depth of 10 ft of until suitable material is found. Figure 3 of Appendix D shows the recommended sub-excavation and subsurface rebuilding plan.

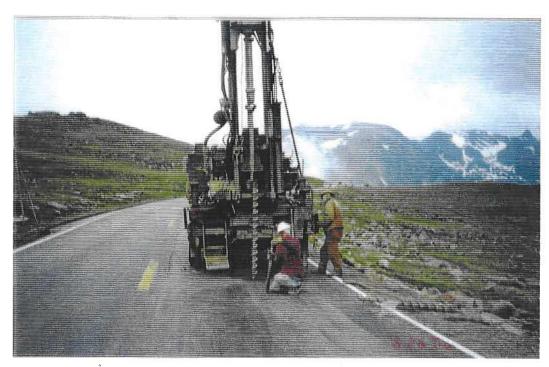
Two borings were advanced along the roadway in this area to characterize the subsurface conditions and to determine the causes and depth of the subsided zones. Boring 00P-108 was advanced a total of 21 ft (6.45 m) below the road surface and was located in the outbound lane at approximately 6.5 ft (2 m) from the road centerline. The soil encountered was mostly well-graded, yellow brown silty sand with some rock fragments, classified as SM by the USCS. Standard Penetration Tests (SPT) measured at 5ft (1.5 m) intervals yielded a low N value of 7 for the soils to a depth of 16.5 ft (5 m) and an N value of 21 for the soils below a depth of 20 ft (6 m). The high SPT N-values measured at 10 ft (3 m) depth are most likely an indication of a boulder zone. This indicates that the soils are loose within the first 16.5 ft (5 m) depth. Boring 00P-109 was advanced at the same station as 00P-108 for a total of 16.5 (5 m) below the road surface

SITE A, BORING B-108 LOCATED 5.85 MILES EAST OF ALPINE VISITOR CENTER, 2.0 m. LEFT

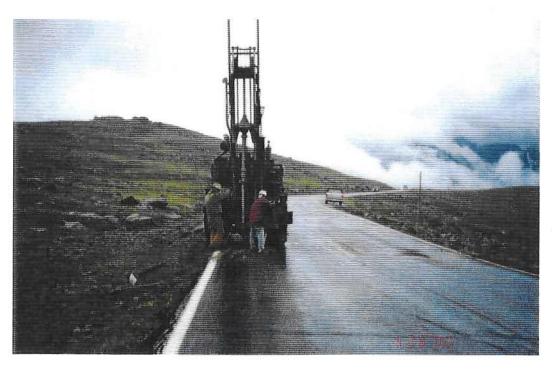
and was located in the inbound lane at 6.5 ft (2 m) from the road centerline. The soil encountered was similar to that in 00P-108 and was also classified as SM by the USCS. At this location, however, the measured SPT N-values were more than two times (N= 14, 15, and 23) those in the outbound lane. Although these N values are not very high, they indicate that most of the problems are caused by soil washing out below the outbound lane.

SITE A, BORING B-109 LOCATED 5.85 MILES EAST OF ALPINE VISITOR CENTER, 2.0 m. RIGHT

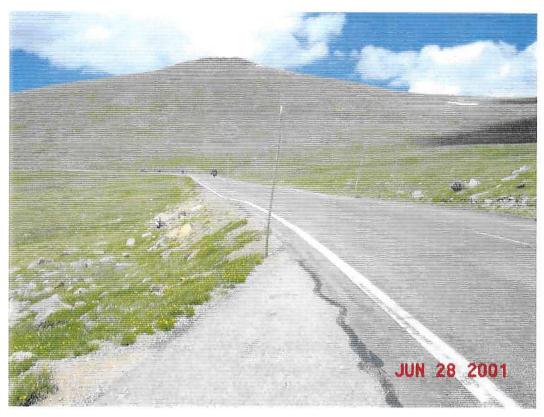
AREA OF SUBSIDENCE ALONG ROAD AT SITE A, LOOKING NORTH

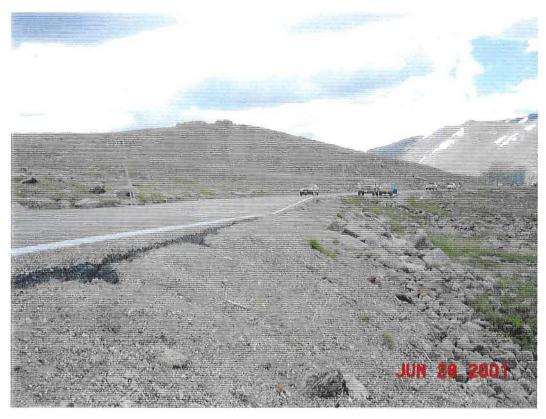
AREAS OF SUBSIDENCE ALONG ROAD AT SITE A, LOOKING SOUTH

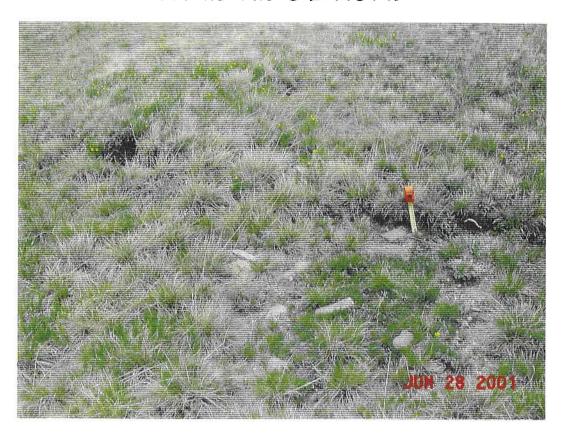
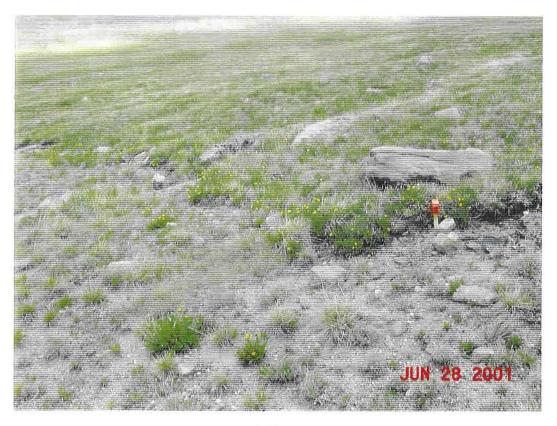
SCARP ALONG EAST SIDE OF SITE A

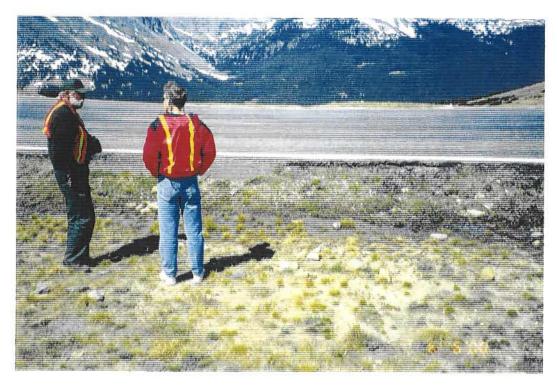
STANDING WATER ALONG ROAD AT SITE A

Because of the topographic nature of the site and the potential for large amounts of water to infiltrate the soils or run across the road, it is also recommended that a qualified hydrologist perform a detailed hydraulic evaluation to quantify the volume of water penetrating the soil. It is possible that the current structures handling drainage along this section of the road may be undersized and unable to handle the large amounts of runoff during periods of snowmelt. All culverts and inlets should be inspected periodically and flushed, if necessary, to optimize their performance.

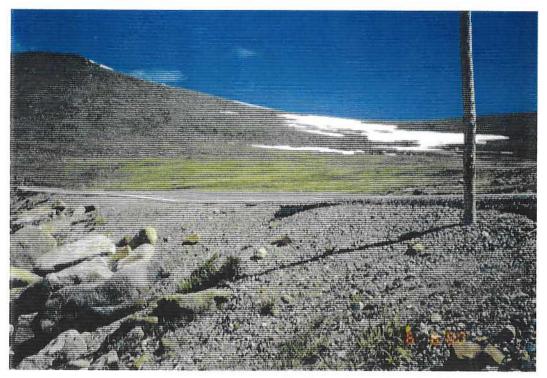
AREAS OF SUBSIDENCE ALONG ROAD AT SITE A

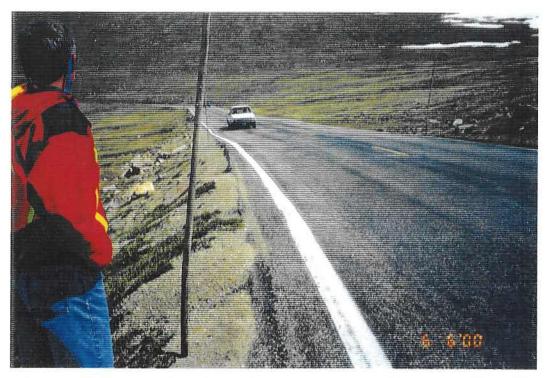
AREAS OF SUBSIDENCE ALONG ROAD AT SITE A, LOOKING NORTH

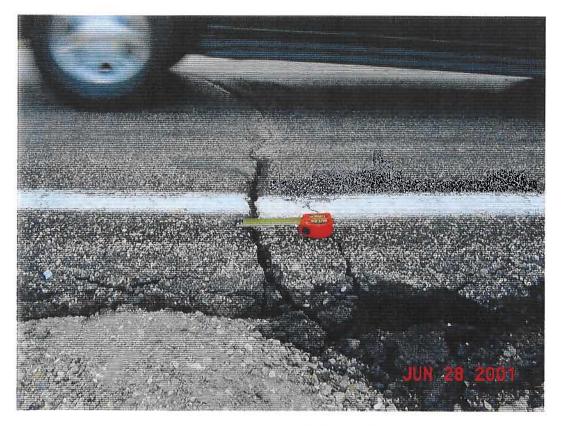
TRANSVERSE CRACKING ALONG SITE A

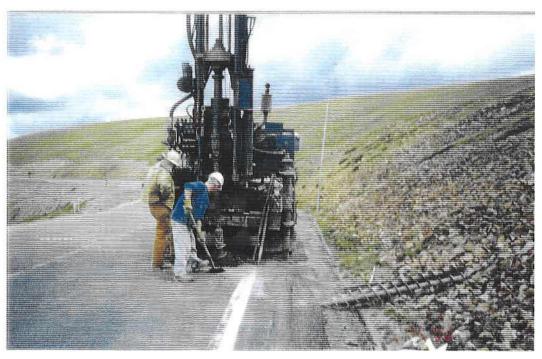
BORING B-102 AT SITE B, LOCATED 1.48 MILES EAST OF ALPINE VISITOR CENTER, 2.9 m RIGHT

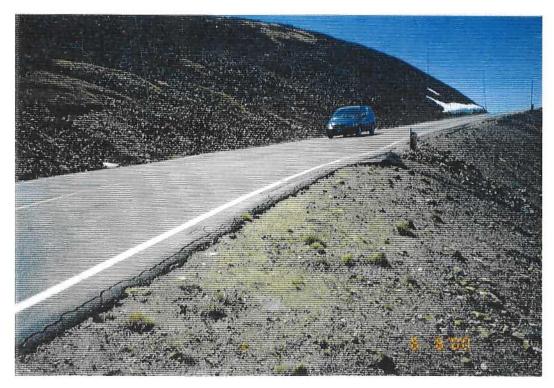
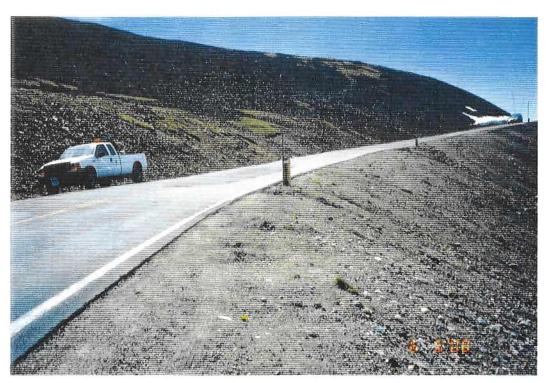
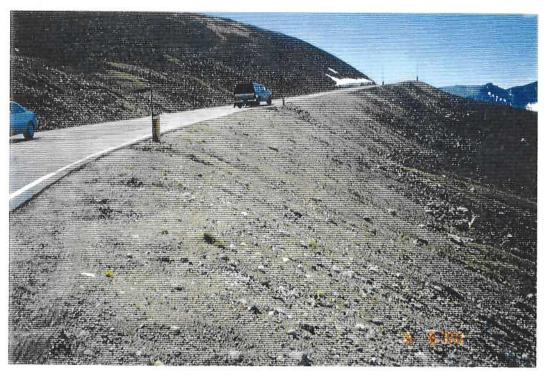
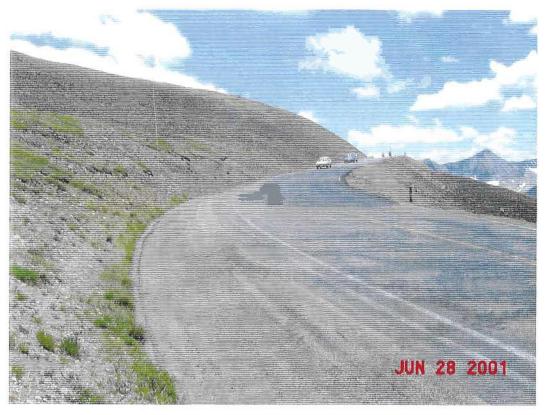
AREA OF SUBSIDENCE ALONG ROAD AT SITE B, LOOKING SOUTH

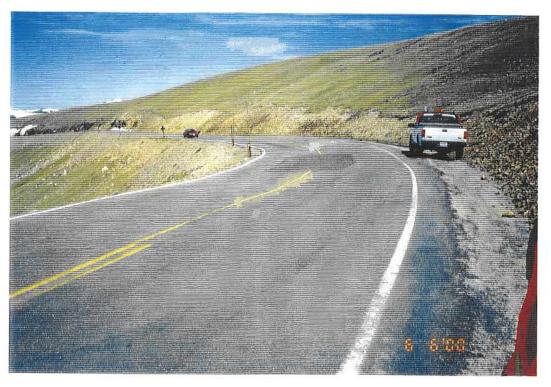
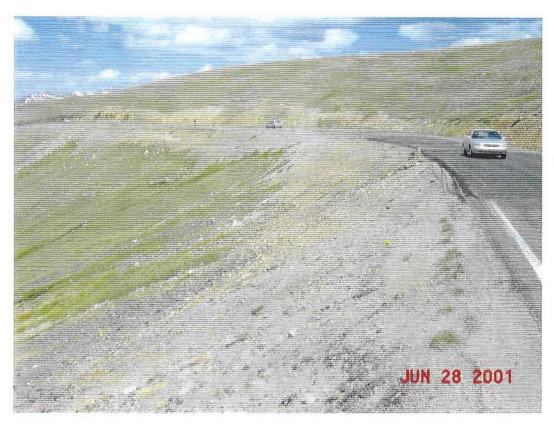
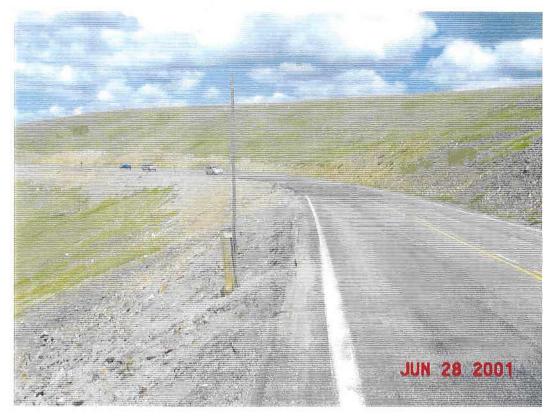
AREA OF SUBSIDENCE ALONG ROAD AT SITE B, LOOKING NORTH

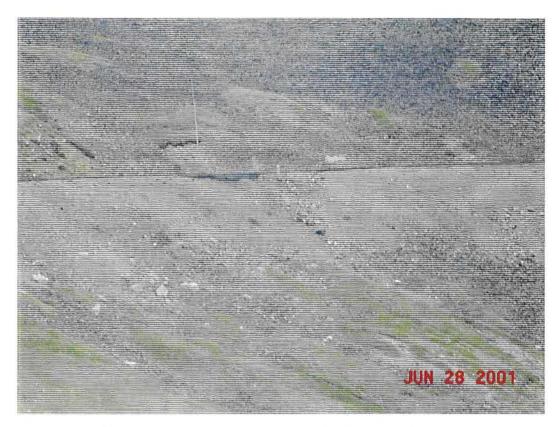
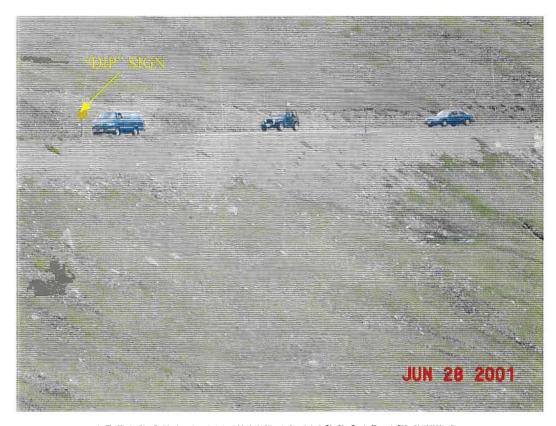
AREAS OF SUBSIDENCE ALONG ROAD AT SITE B

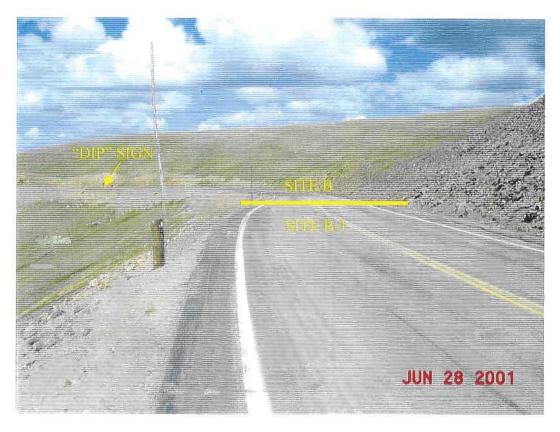
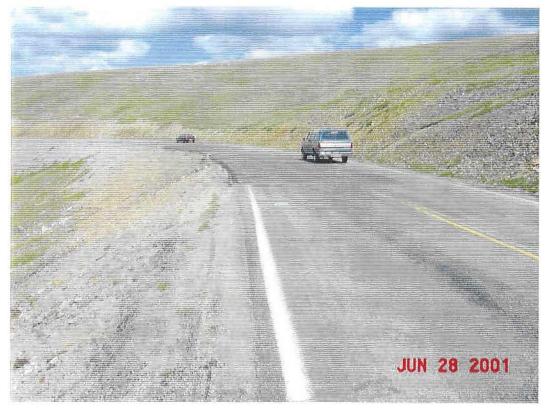
AREAS OF SUBSIDENCE ALONG ROAD AT SITE B, LOOKING NORTH

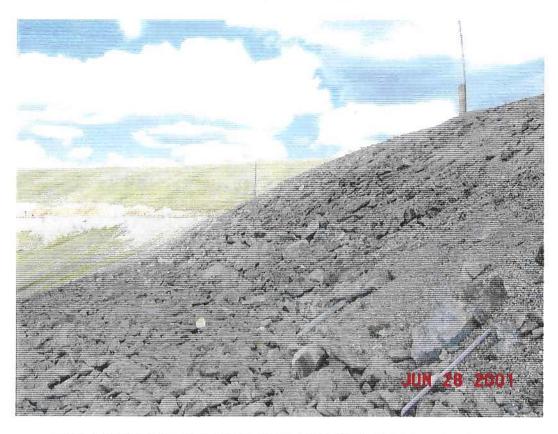
FILL MATERIAL ON WEST SIDE OF SITE B, LOOKING NORTH

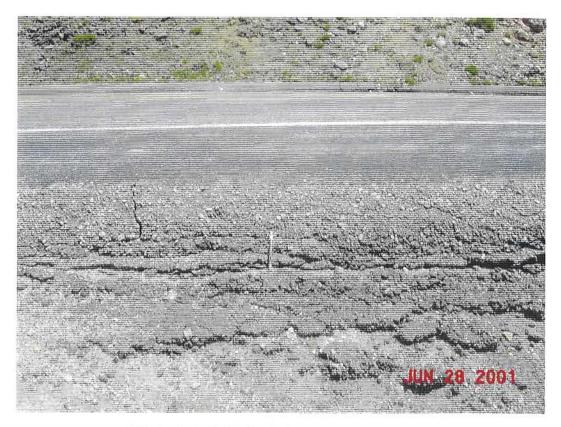
Site D: Site D is a small section of Trail Ridge road that was investigated during the site visit in June 2001. Site D is approximately 195 ft (60 m) north of a stonewall found just north of the Lava Cliffs Turnout. Site D is 100 ft (30 m) long and consists of a 6 in (150 mm) dip found adjacent to a "20 MPH" curve sign along the outbound lane. A paved ditch with a 6 in (150 mm) curb is used to control drainage on the east side of the road. Low to moderate transverse cracks was observed with a spacing of approximately 10 ft (3 m). Site D consists of cut and fill slopes, with the toe of the fill slope 30 ft (10 m) below the road surface.

SHOULDER DROP ALONG ROAD AT SITE D
